# Manhole Inspection Summary

Manhole # S41I\_\_018MH

Insp Date: **5/14/08 11:30 AM**

**Location** Address: **1400 gough st**

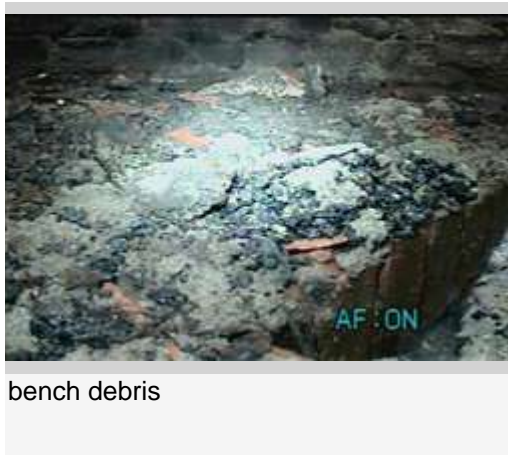
Defect 3

Condition: ☐ Sound ☐ Cracked ☐ Root Intrusion ☐ Deteriorated ☐ Leaks ☒ **Debris**

bench debris

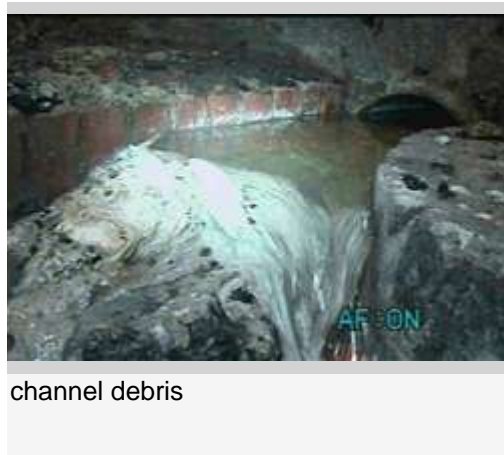
Defect 2

Condition: ☐ Sound ☐ Cracked ☐ Root Intrusion ☐ Deteriorated ☐ Leaks ☒ **Debris**

channel debris

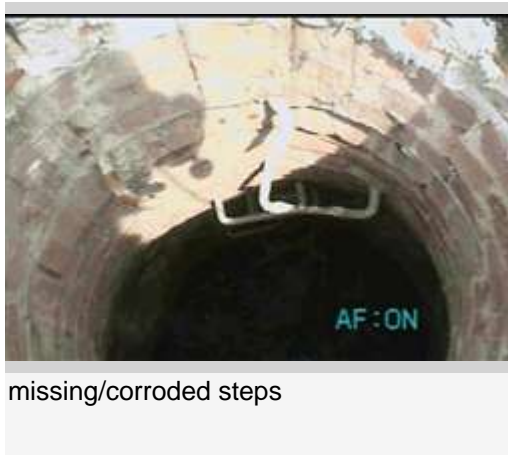
Defect 1

**Steps** Count: **6** Missing: **1** ☒ **Corroded**

missing/corroded steps

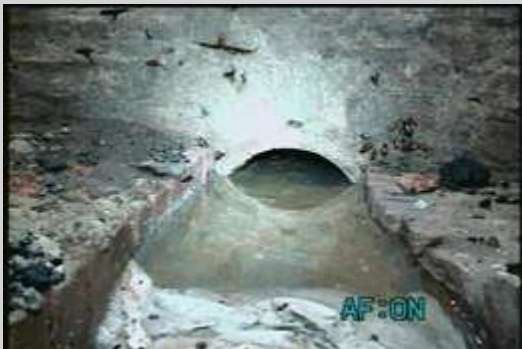
9 O'Clock Inflow

Deposits: ☐ None ☐ Mud ☐ Sludge ☒ **Debris** ☐ Grease

Silt Depth: 6 (in.) Deposits Extent: **Heavy**
